ANATOMY OF FUSELAGE REPAIRS

The first part of this file is about doing a repair on the glassed-over fuselage. The latter part covers some repairs on composite fuselages.

REPAIRING A BROKEN GLASS FUSELAGE

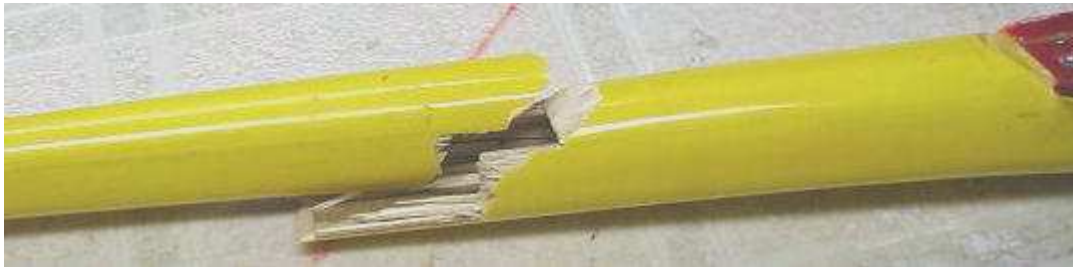
The glassed-over fuse will stand a pounding on landings, but two weird calamities in 15 years have snapped the boom area. On 4/14/04 I launched the prototype LT/S on a strong hi-start and caught the wing on my wide-brimmed hat. The ship could not be straightened up before going inverted, spearing the ground under full tension, tow ring still attached. This was a really hard rap. The tips disengaged and other than some minor delaminations where they plugged in, there was no wing damage. However, the fuse broke about 6" behind the wing.

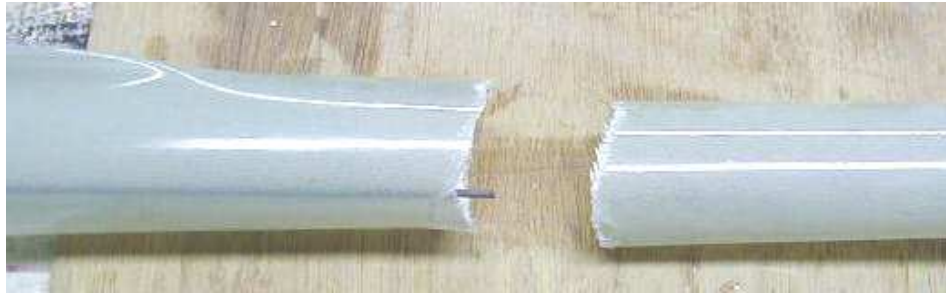
The picture below displays the result of launching on a short high start with the Tx switch off. Such events instill humility and present an “educational opportunity”.

After “study” I decided to use the tapering rear section as a form around which to create a sleeve to install inside to rejoin the two sections. With bagging wax, I applied and polished three coats so epoxy would not bond to it.

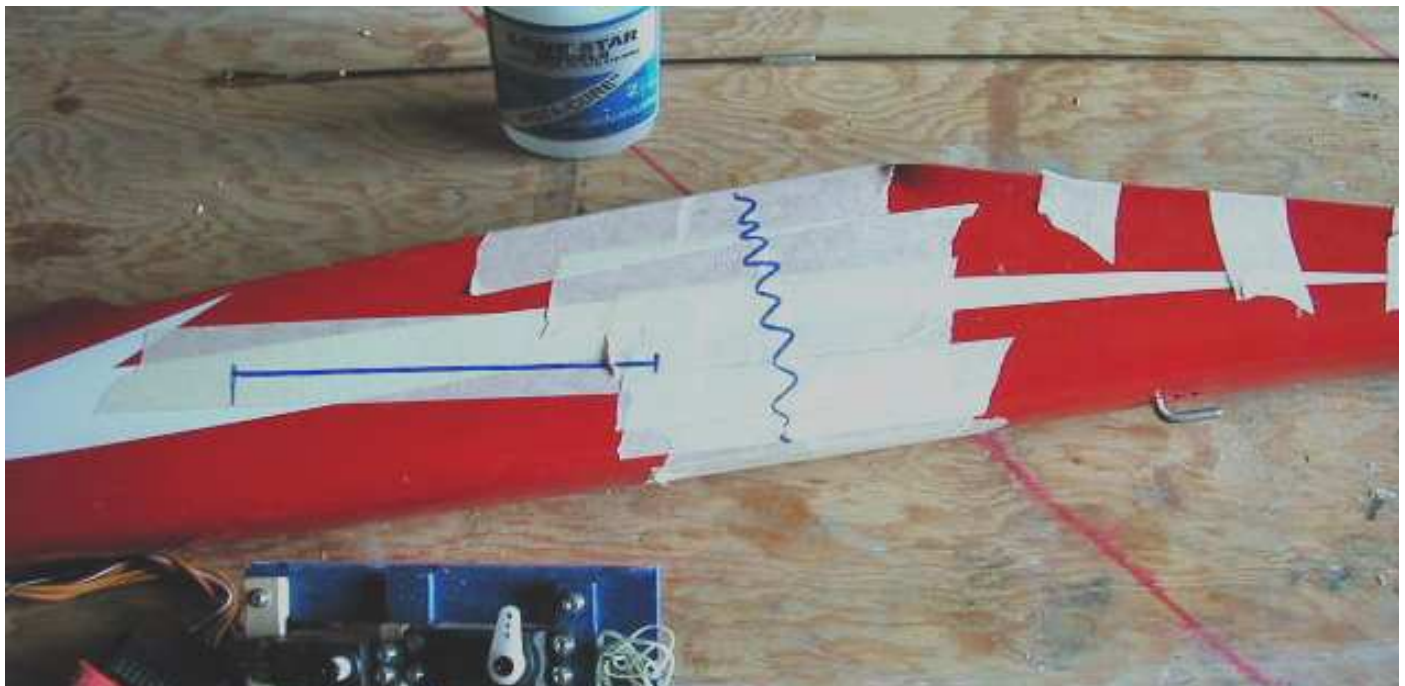
At impact, the fuselage was severed ahead of the wing, the servo tray dislodged and the CF pushrod broken in two. My repair approach was as follows:

The solid, angled blue line is where the tray goes back. The squiggly line is the location of the break which is similar around the bottom and up the other side.

Take stuff out of the fuselage, clean up the severed edges, align the parts, join them with instant CA glue and apply tape on the outside to hold stuff together well. Then inside, using bagging epoxy, laminate some CF and glass cloth pieces over the breaks.

Preparation is shown below. In the intact saddle area, I taped the rudder cables out of the way.

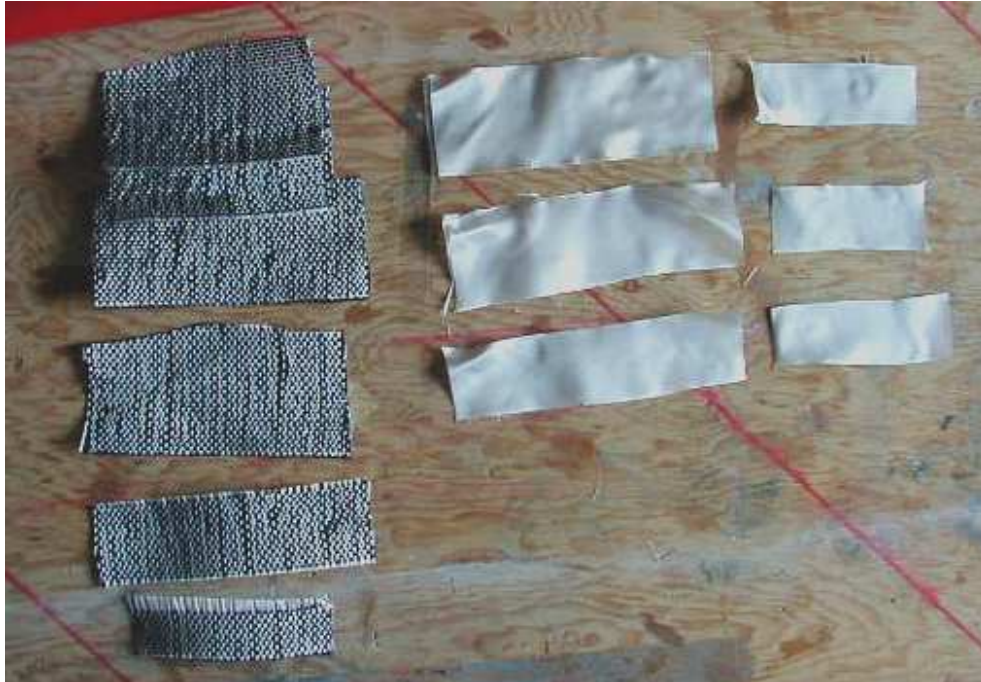
The CF pushrod by the glue bottle had snapped and had a shattered area. Using a split sleeve and CA, a section of scrap pushrod was joined on to restore original length.

The next pics show the pieces of CF cloth and glass sized to go inside and tools used.

Larger cloth pieces were cut about 5" long to extend either side of the breaks. CF went down first, then the smoother glass pieces.
