ANATOMY OF FUSELAGE REPAIRS

The first part of this file is about doing a repair on the glassed-over fuselage. The latter part covers some repairs on composite fuselages.

REPAIRING A BROKEN GLASS FUSELAGE

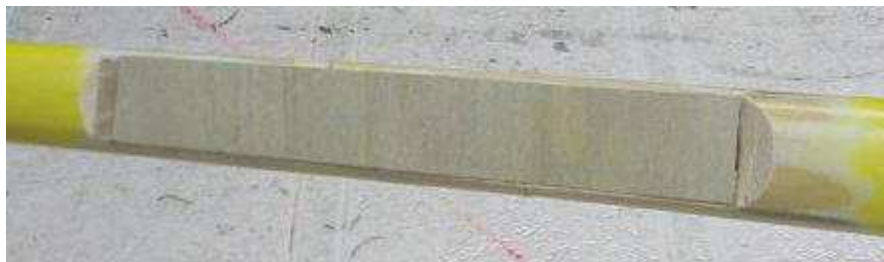
New triangular stock was applied where the ply doublers made corners and where new 1/64" ply was to be replaced on the bottom.

The doublers were to be attached with epoxy, one at a time, carefully eyeballing to retain the original alignments. The one at the top was attached first to the intact 1/64" ply. The side ones were then separately attached.

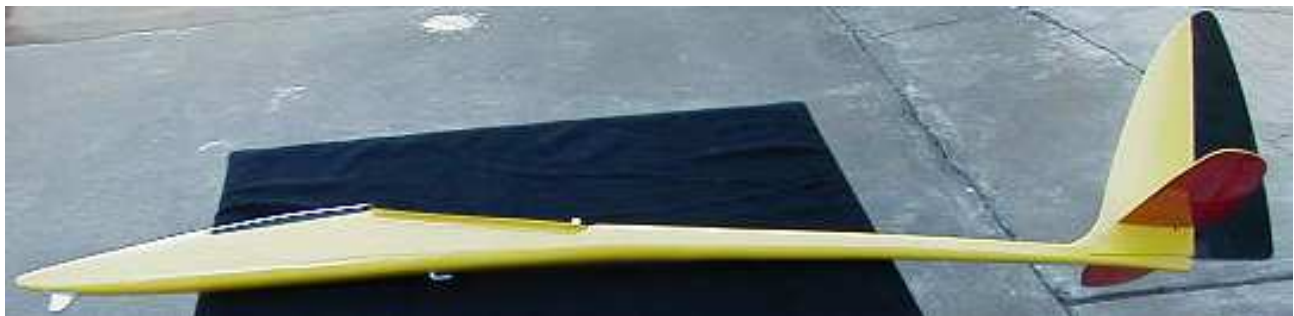
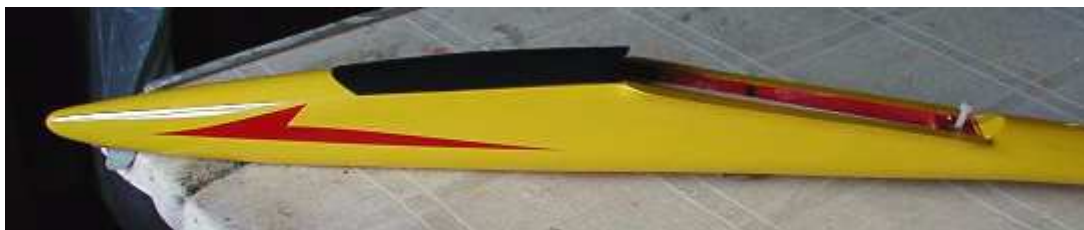
The restored fuse looks like new and is stronger than it was originally. The repair can't be found. Using a hacksaw and files, a hook tooth was made from a piece of aluminum T-bar to screw attach under the nose. Servos are in, new canopy fine-fitted and painted. Rudder cables and pushrod are hooked up, ready to fly.

Red accent was added to spiff it up a bit. Color rendition indoors is better than outside.

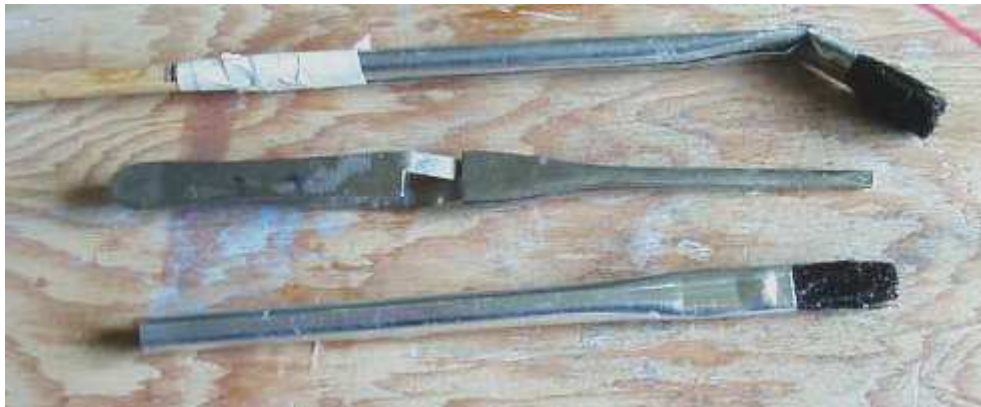
At impact, the fuselage was severed ahead of the wing, the servo tray dislodged and the CF pushrod broken in two. My repair approach was as follows:

Larger cloth pieces were cut about 5" long to extend either side of the breaks. CF went down first, then the smoother glass pieces.

The long tweezers helped position pieces to be wet out one at a time.

The epoxy was warmed to reduce viscosity and readily penetrate the pieces.
